NRL Memorandum Report 5699

Cracking Resistance in a 4.5-inch (114-mm) Plate of 7075-T7351 Aluminum Alloy

G. R. YODER, L. A. COOLEY, T. J. WATSON AND T. W. CROOKER

*Mechanics of Materials Branch
Material Science and Technology Division*

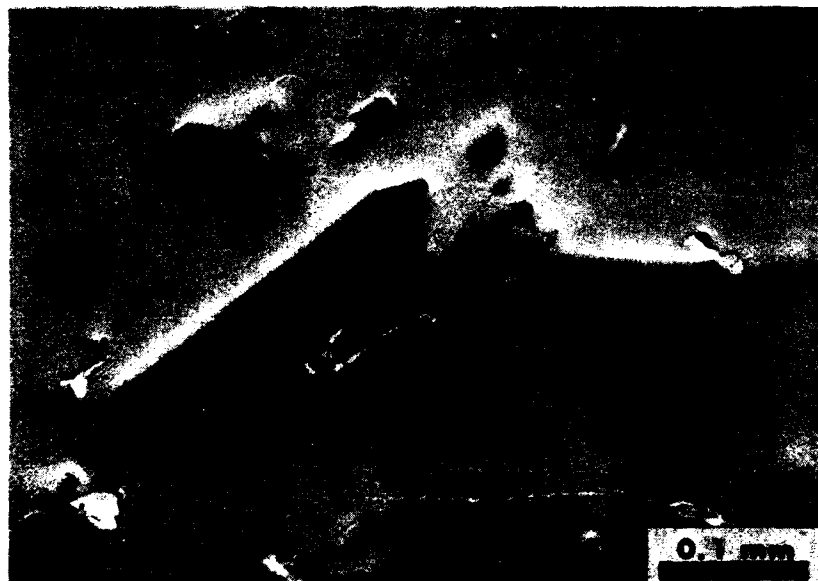
Fig. 7 - Large shrinkage cavity at plate midthickness location, as polished.

On infrequent occasions, defects much larger than the scale of constituent particle dimensions were observed. From their morphology, these appear to be rather gross shrinkage cavities - with dimensions as large as 0.016 inch (400 μm). It is difficult at this point to fully characterize the distribution of these very large cavities in the plate, as they have been observed in only three instances (all from the plate midthickness location) from among some two dozen or so metallographic samples. One of these shrinkage cavities is illustrated in Fig. 7. However, numerous other cavities similar in morphology but significantly smaller in dimension have also been observed.

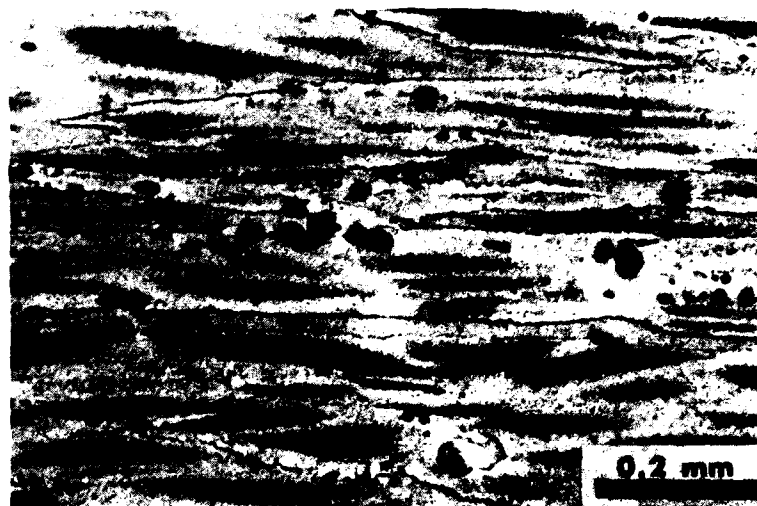
Fig. 9 - Microstructure as etched with Keller's reagent, plate midthickness location, T-orientation.

The microstructure, as etched with Keller's reagent, is shown in Fig. 9 for the T-orientation at the plate midthickness location.

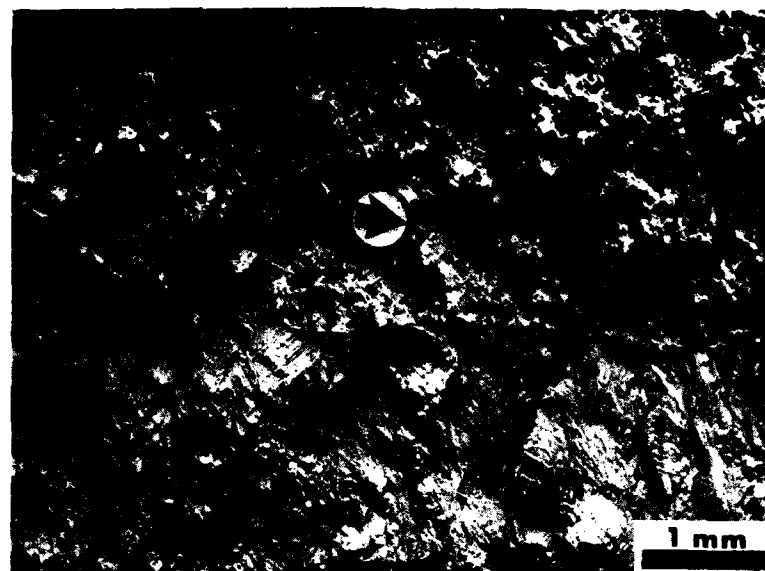
Fig. 13 - Scanning electron micrograph of fracture toughness specimen of LT orientation with fatigue precrack zone in lower half; direction of crack growth is from bottom to top. Arrow points to secondary crack along S-plane in fracture process zone.

enhanced toughness level. Preliminary examination of one of the compact tension specimen fracture surfaces in the scanning electron microscope appears to support this contention, as a number of secondary cracks along the S plane are apparent in the fracture zone of the LT toughness specimen exhibited in Fig. 13.
